Manhole Inspection Summary

Manhole # S13QQ1020MH

Insp Date: **11/1/06 12:41 PM**

Location Address: **2800 GARRISON AVE**

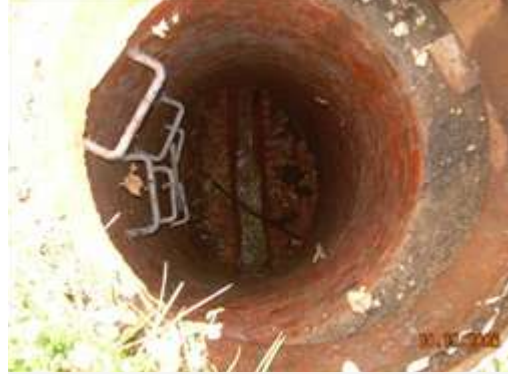
Top View

Bench debris. Frame leaks. Frame offset. Adjustment deterioration, loose brick, and infiltration. Corbel infiltration.

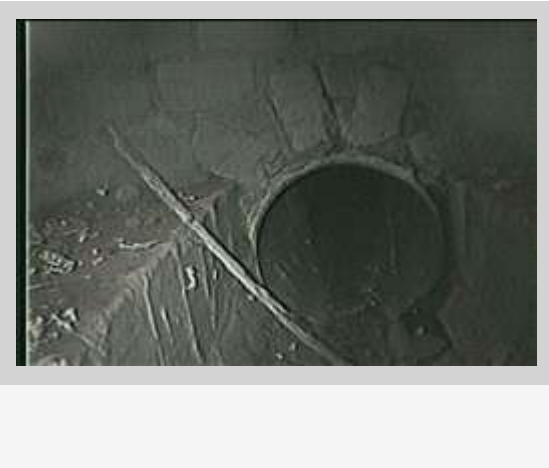
8 in. Circular Gravity Sewer Pipe Out @ 12 O'Clock

Infiltration: **Evidence** Pipe Seal Cond: **Cracked**
